Effect of Ground Vibration to Slope Stability, Case Study Landslide on The Mouth of Railway Tunnel, Gunung Gajah Village, Lahat District

Abstract

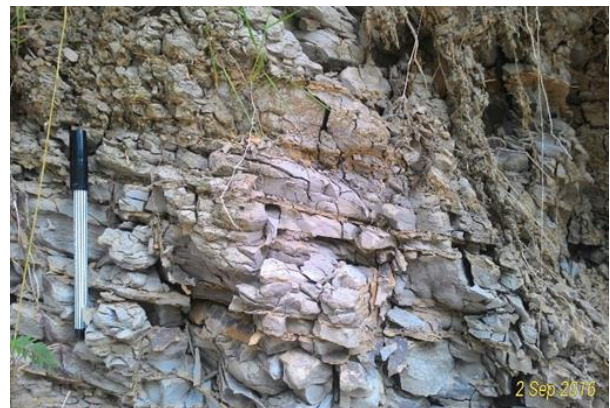
Figure 3. Orientation of Rock Outcrop

Based on observations and measurements of the rock structure layers through the wall of landslide on research area and test pit data, the orientation of the rock structure layers, strike trending East-West N 100°E and dip ranged from 20° to 30° (Figure 3).

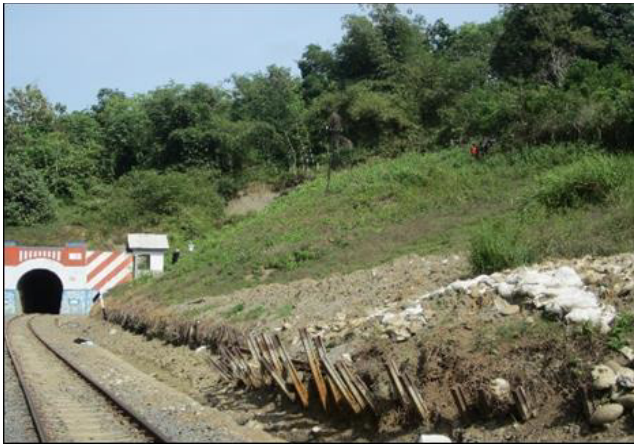
Figure 4. Unfavorable slope on Research Area

The orientation of rock structure layers that have same direction to the slope which is unfavorable slope in the mouth of railway tunnel have high potential to cause landslide (Figure 4).
